# Field Study Photographs for Historic Preservation

Volume 2  
Chemical Cleaners for Architectural Materials,  
Spring, 2003

CHEMICAL CLEANERS

Architectural Conservation (IAR 548) Laboratory Experiments

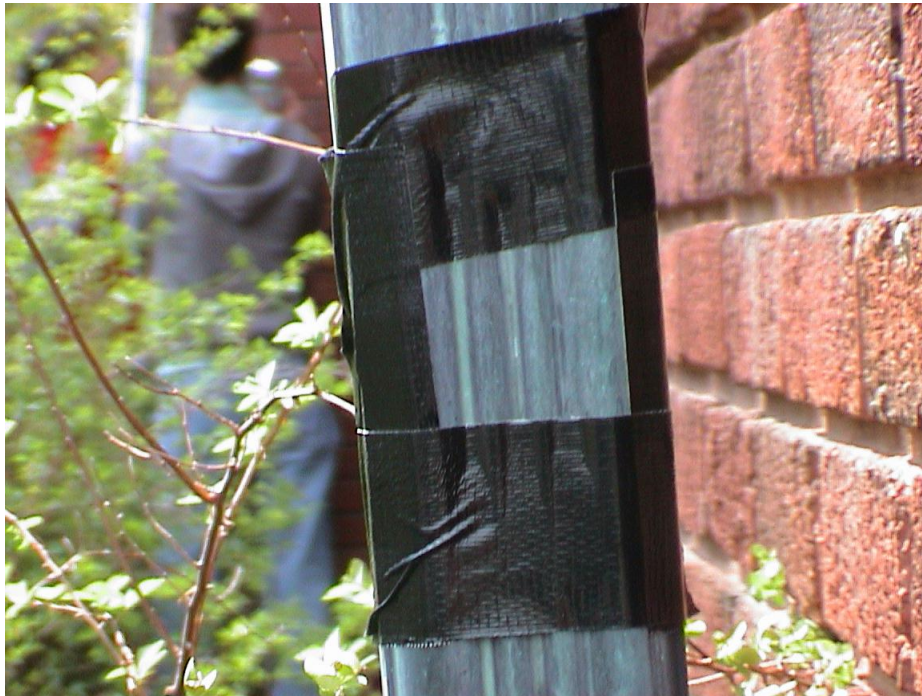
Figure 1. A paste of rottenstone and mineral oil is prepared for removing the patina from copper. A paste of whiting, or talc, and (diluted) ammonia is prepared for removing the patina from copper. Duct tape (or gaffer's tape) is used to prepare a test area on a copper gutter pipe. Two solutions will be tested on this copper pipe. The upper test area (A-1) will be treated with a mixture of rottenstone and mineral oil. The lower test area (A-2) will be treated with a paste of whiting, or talc, and (diluted) ammonia.

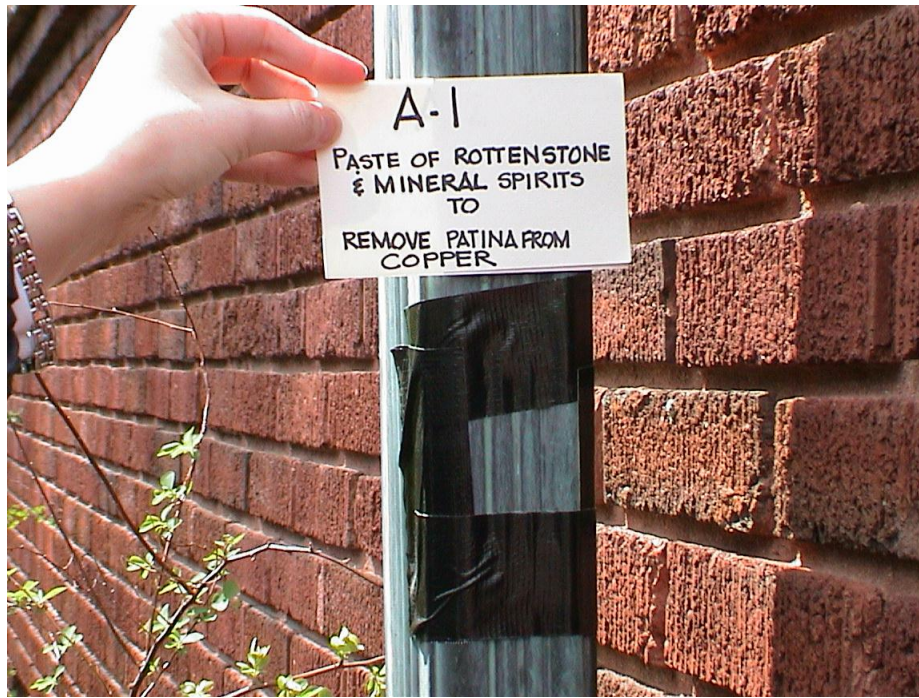
Figure 2. This photograph includes a card identifying the test area and treatment.

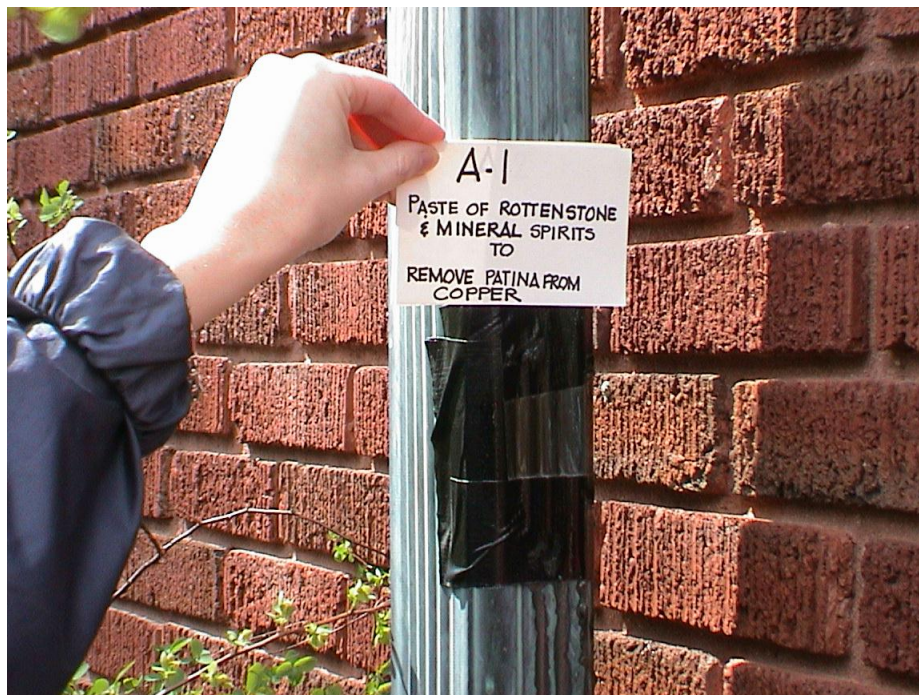
Figure 3. After dampening test area A-1 with a wet sponge, the rottenstone and mineral spirits mixture is applied to the copper pipe.

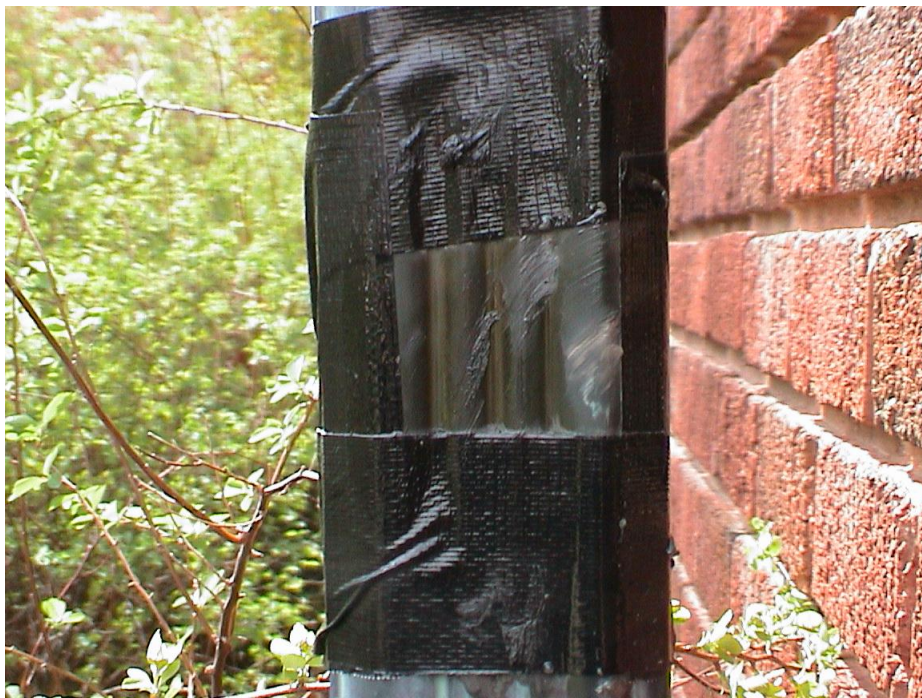
Figure 4. The rottenstone and mineral spirits solution is rubbed into the surface of the copper.

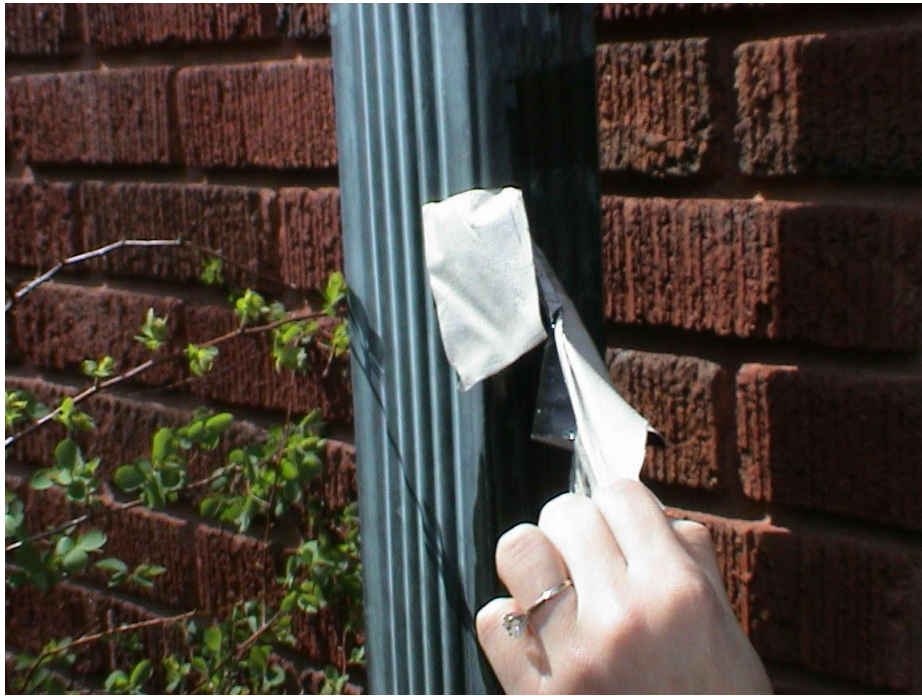
Figure 5. After the solution of rottenstone and mineral spirits has been wiped from the surface of test area A-1, the tape is removed.

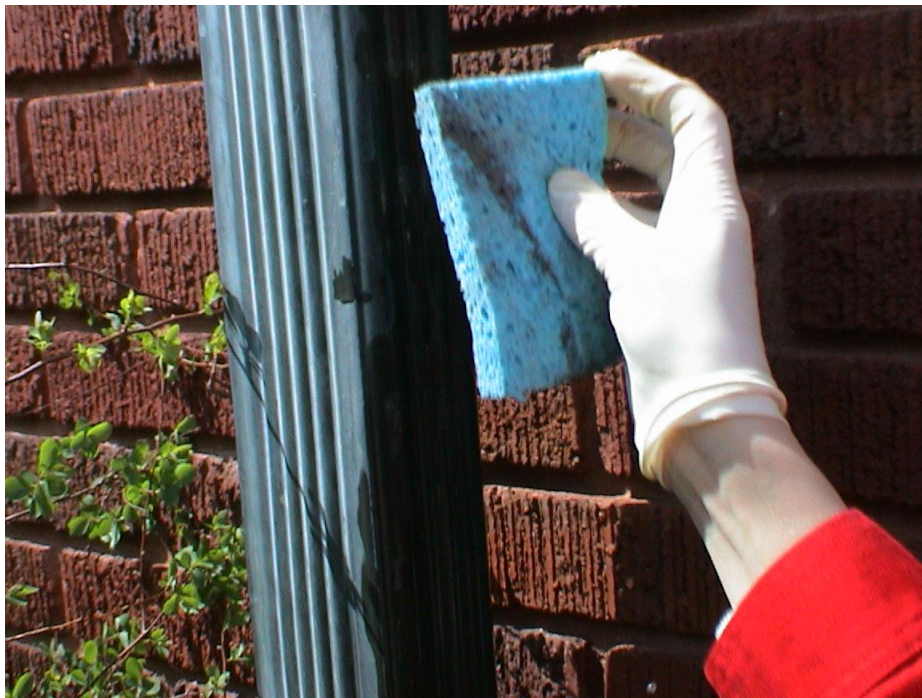
Figure 6. Test area A-1 is thoroughly rinsed, and then sponged dry.

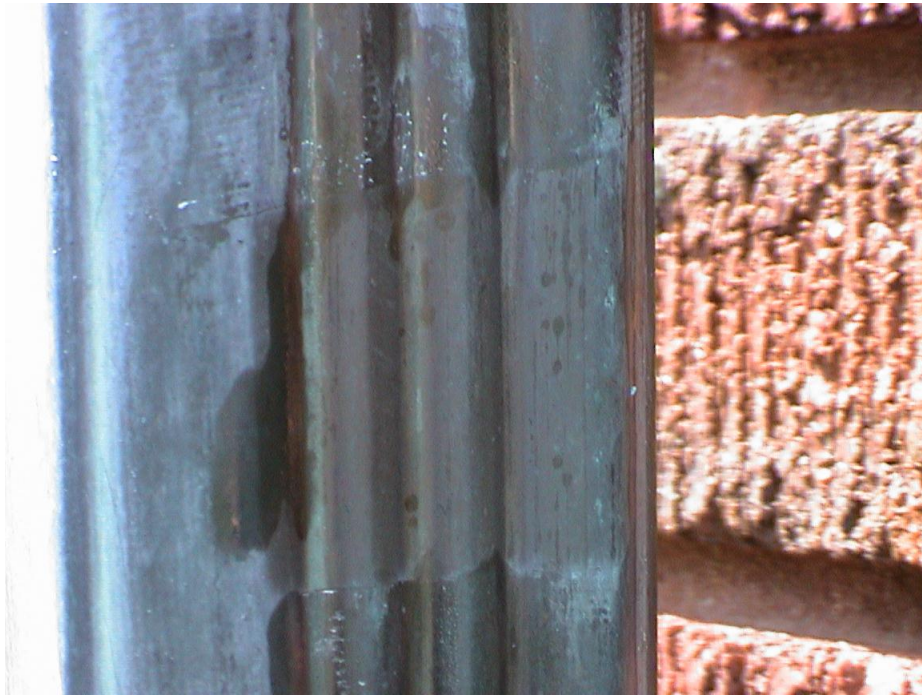
Figure 7. Some of the patina on test area A-1 appears to have been removed by the rottenstone and mineral spirits solution.

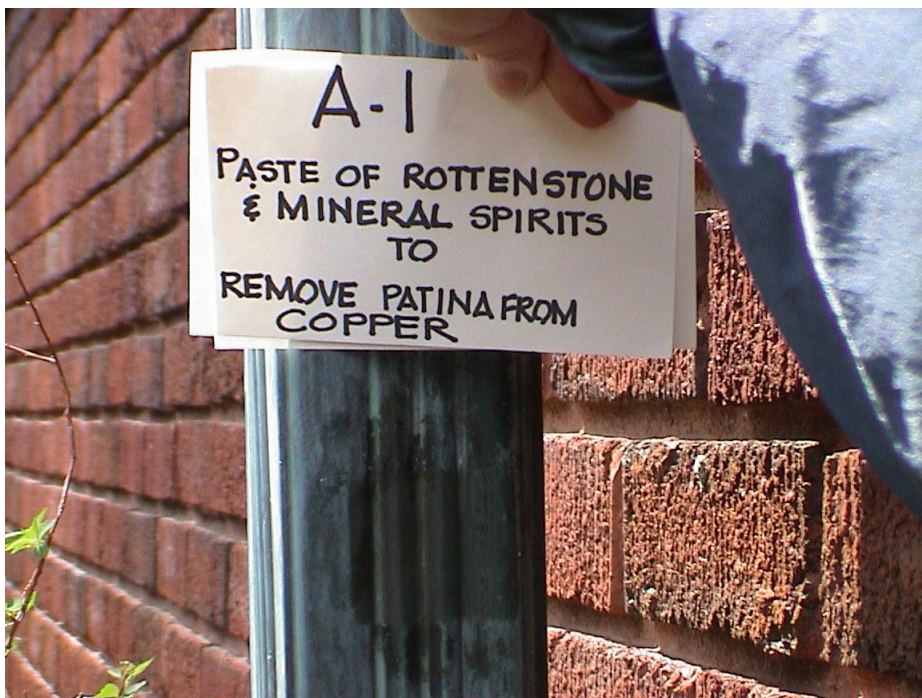
Figure 8. This photograph shows test area A-1 after the surface has completely dried.

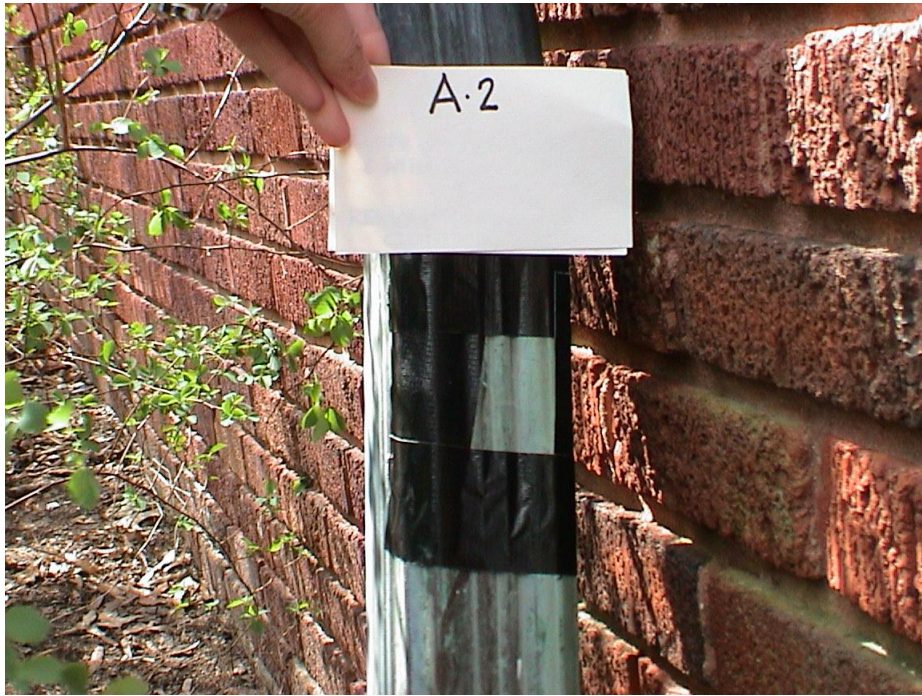
Figure 9. Test area A-2 is located on the lower section of the same copper pipe.

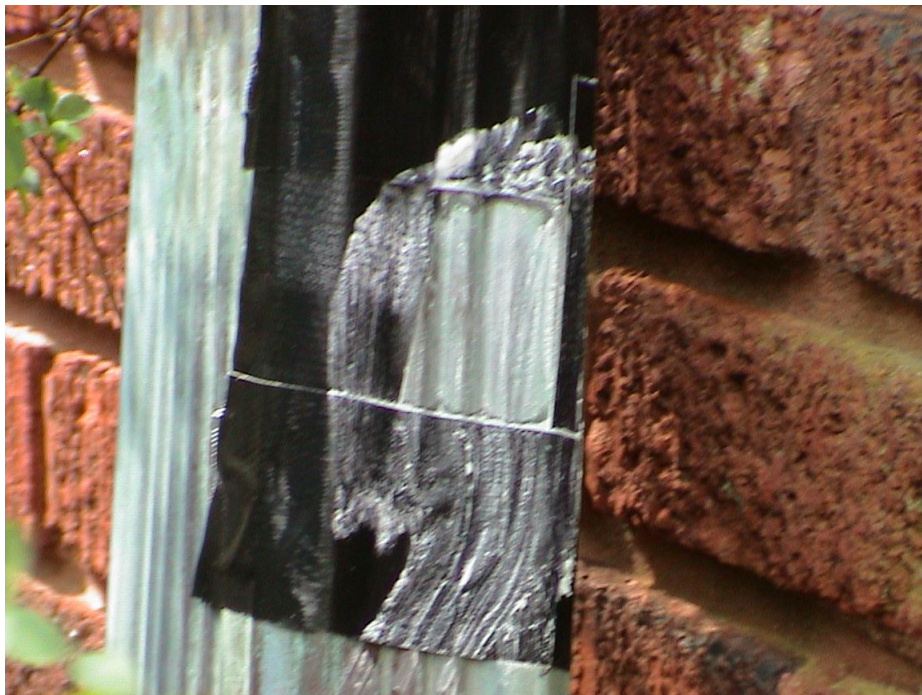
Figure 10. A paste of whiting, or talc, and (diluted) ammonia is applied to test area A-2.

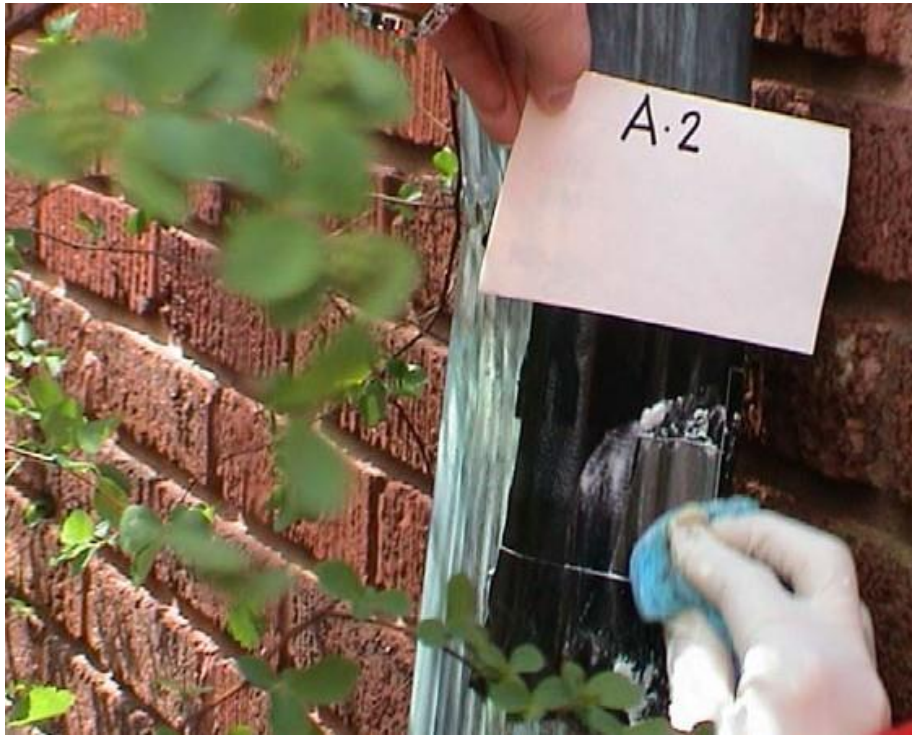
Figure 11. After the paste has been allowed to remain on test area A-2 for a few minutes, it is removed with a wet sponge.

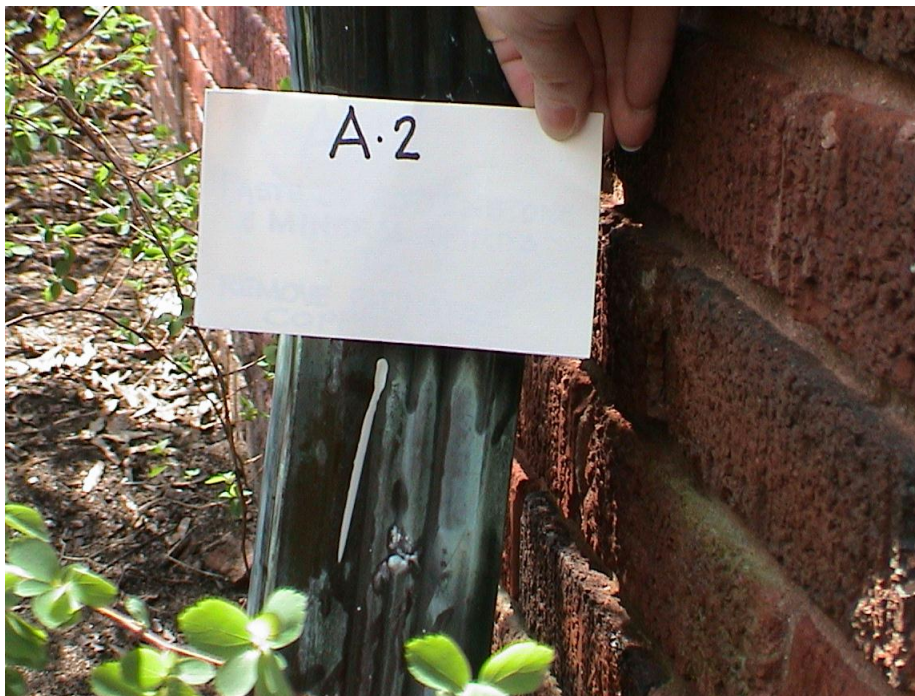
Figure 12. The tape on test area is removed, and the surface is allowed to dry.

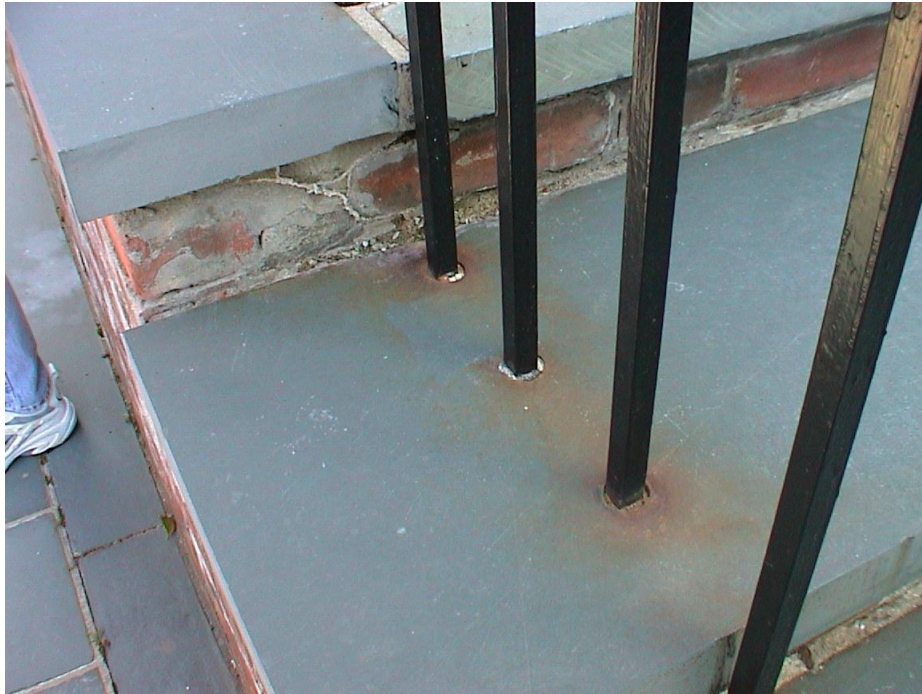
Figure 13. Rust from this iron railing has stained this stone step (note the square from a previous test that was conducted on this stone).

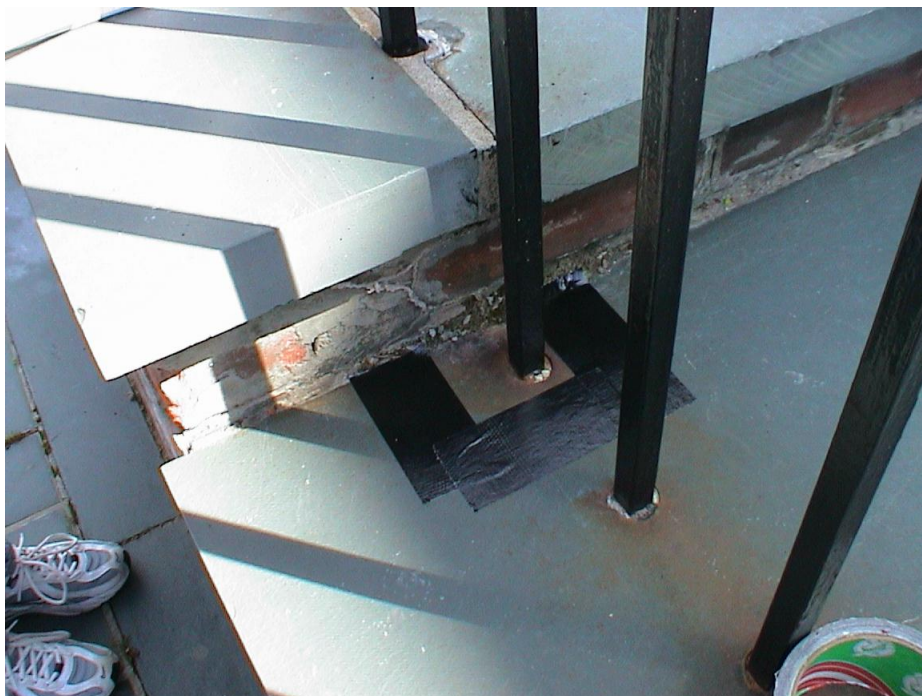
Figure 14. Tape is placed around the first rail to create a new test area.

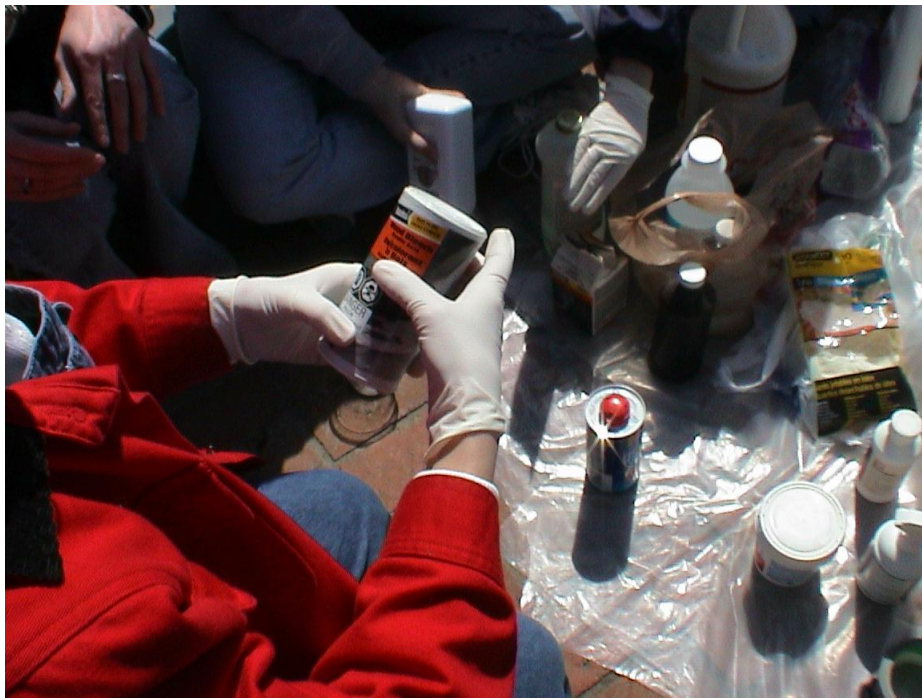
Figure 16. The active substance in the poultice that will be applied to test area B-1 is oxalic acid.

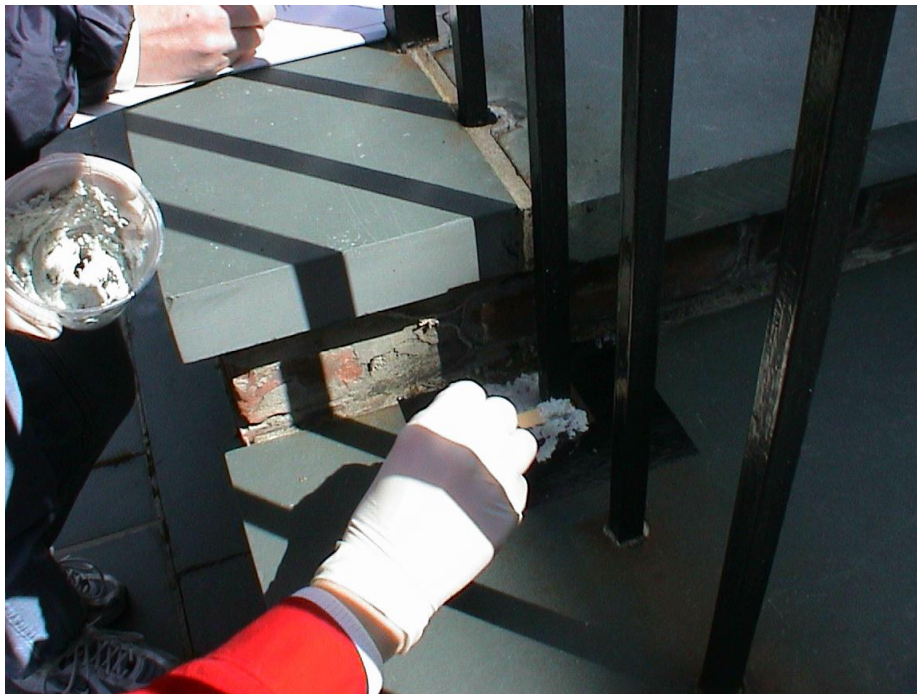
Figure 17. The oxalic acid and talc poultice is applied to test area B-1. Talc, an inert substance, and water are added to the oxalic acid to create a paste that will adhere to the stone surface of test area B-1.

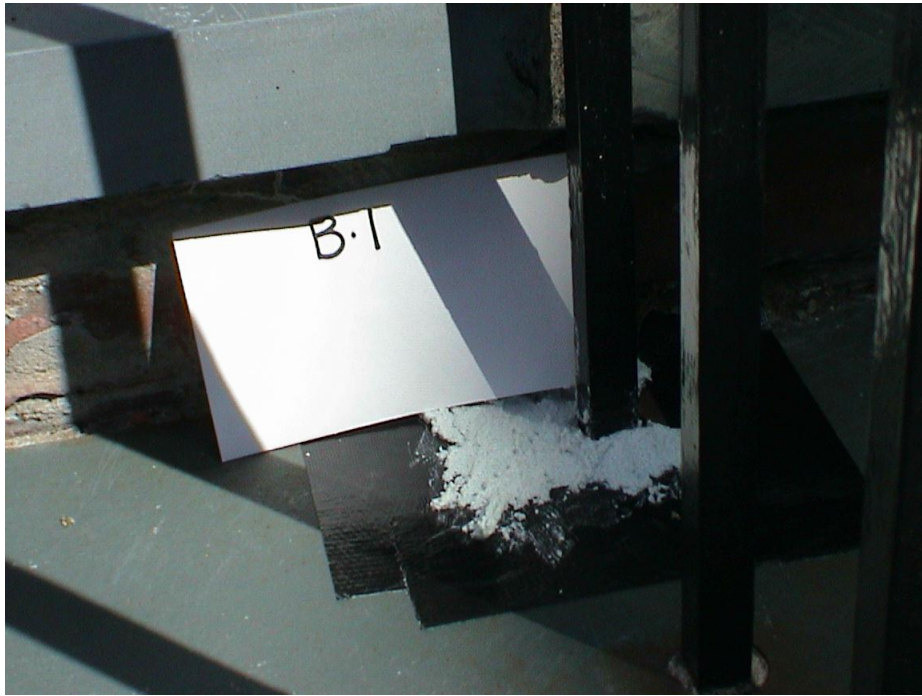
Figure 18. The oxalic acid and talc poultice on test area B-1 is left for one hour.

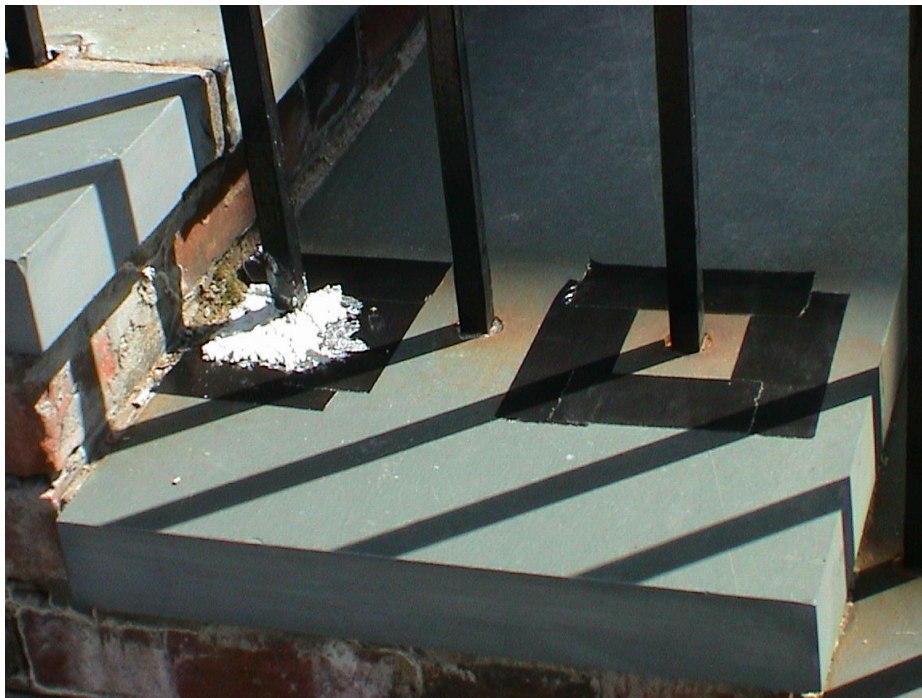
Figure 19. A second area is taped out on the same step.

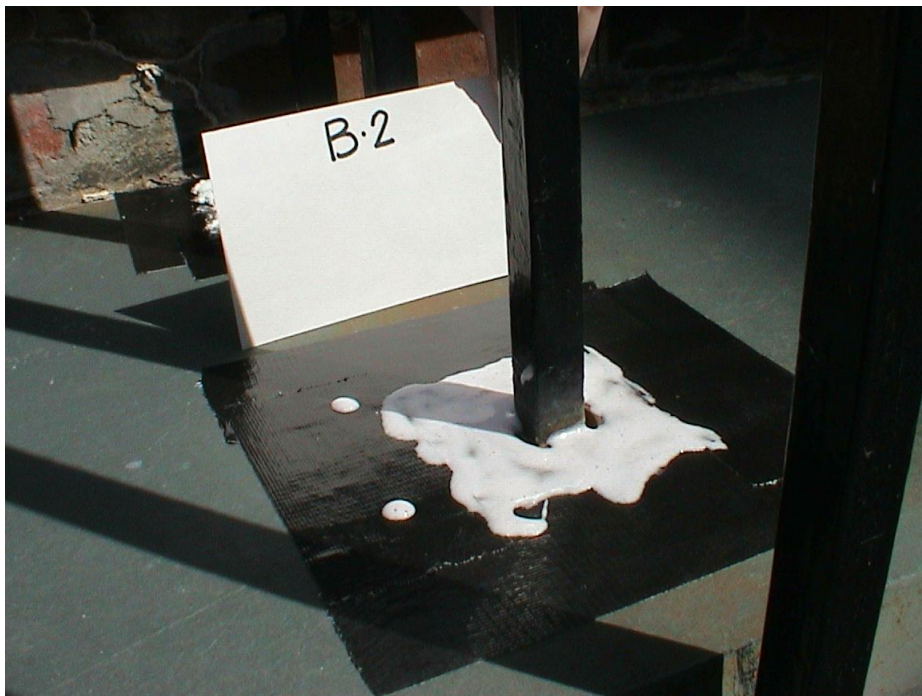
Figure 22. A poultice of orthophosphoric acid (naval jelly) and talc is prepared for application to test area B-2. The poultice of orthophosphoric acid and talc is applied to test area B-2. It will be left for one hour.

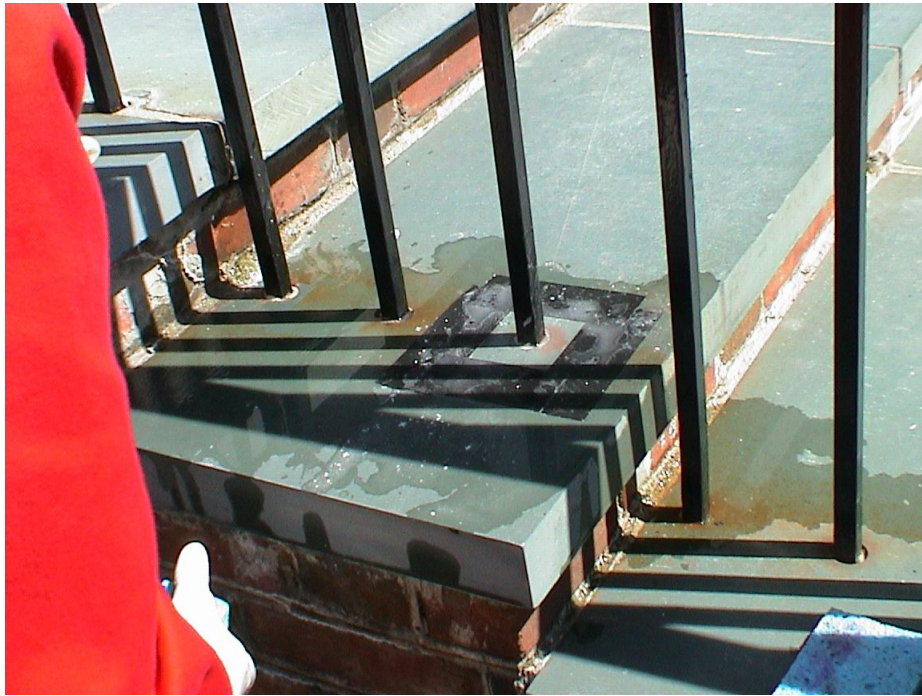
Figure 23. After an hour has past, then poultices are scraped off of test area B-1 and test area B-2. The surface is the thoroughly rinsed.

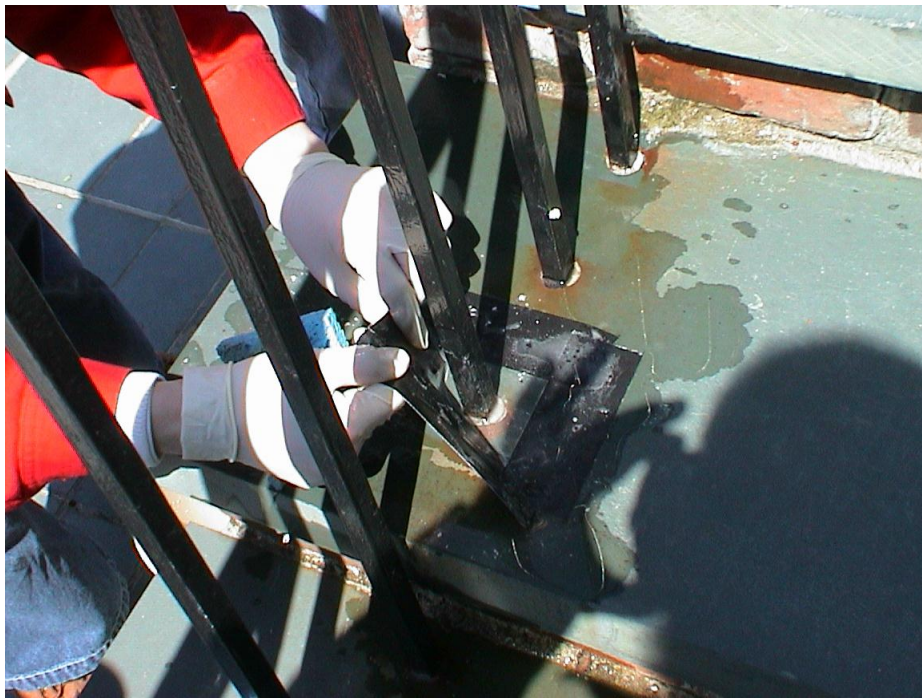
Figure 24. The tape on test area B-2 is removed.

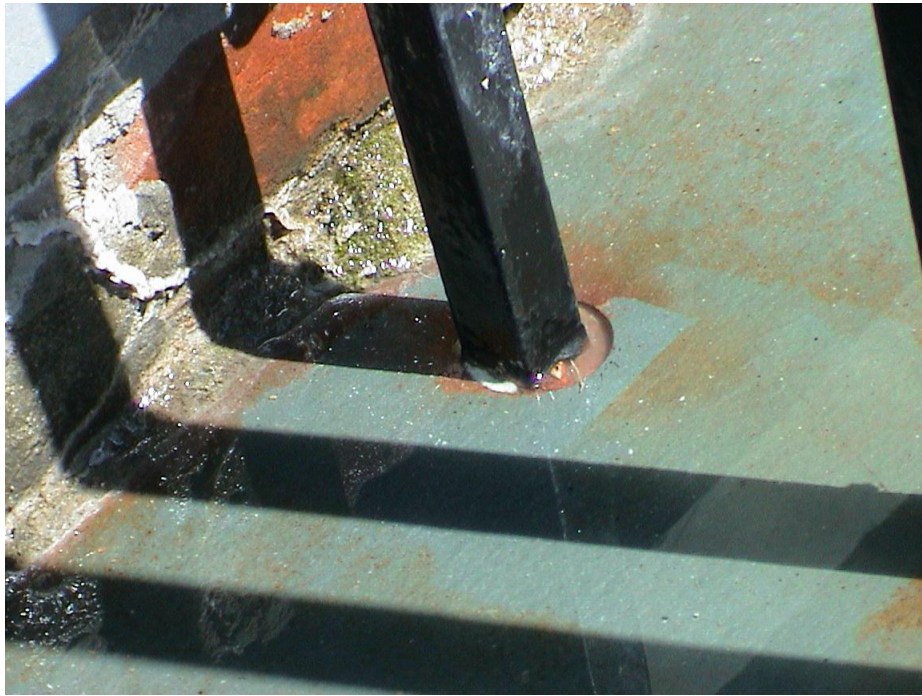
Figure 25. This is a photograph of test area B-1 after the surface has dried.

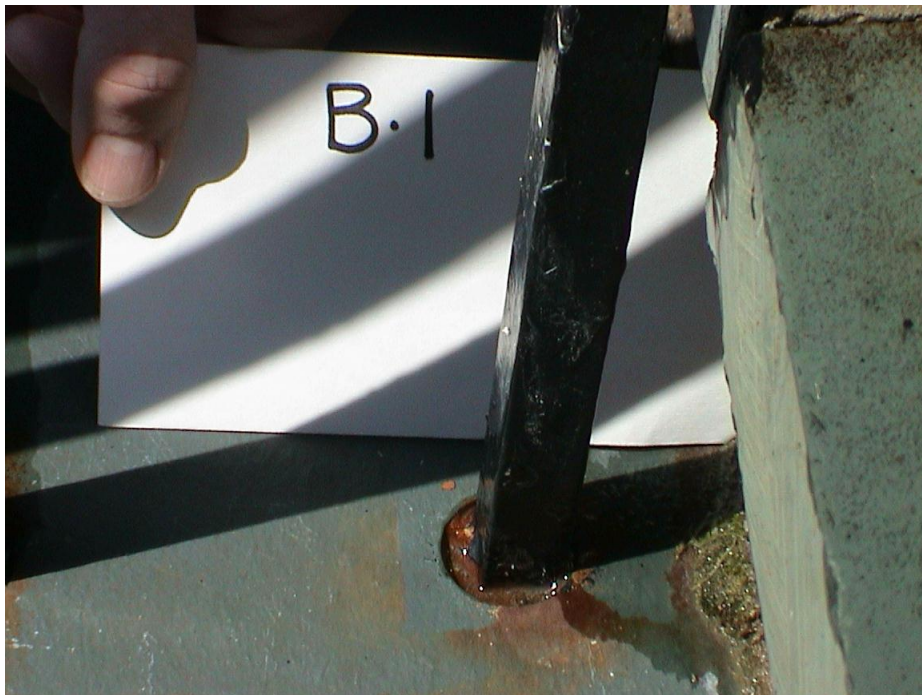
Figure 26. The oxalic acid and talc poultice removed some of the rust stains on test area B-1.

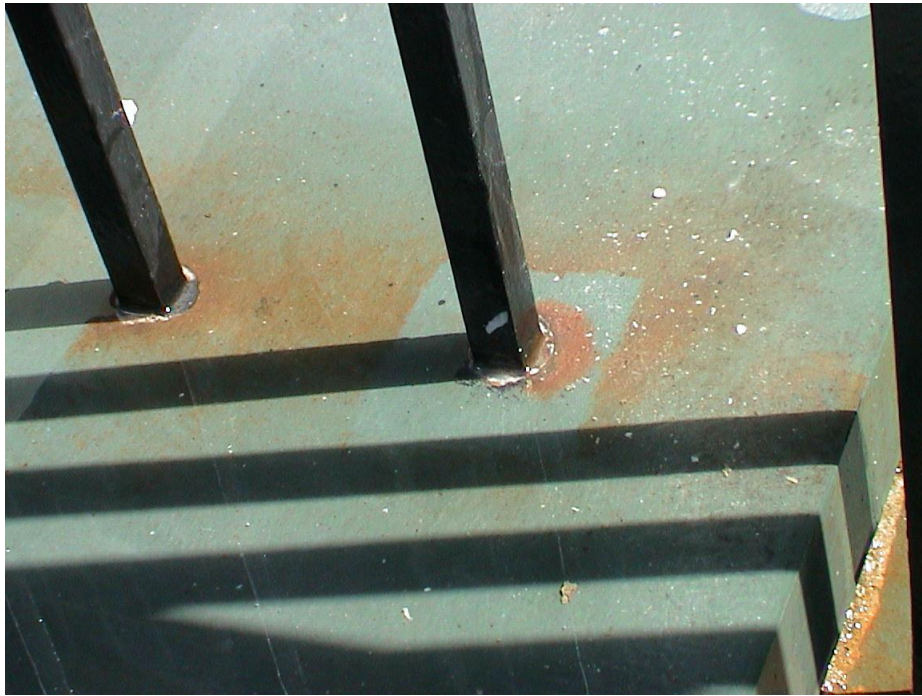
Figure 27. This is a photograph of test area B-2 after the surface has dried.

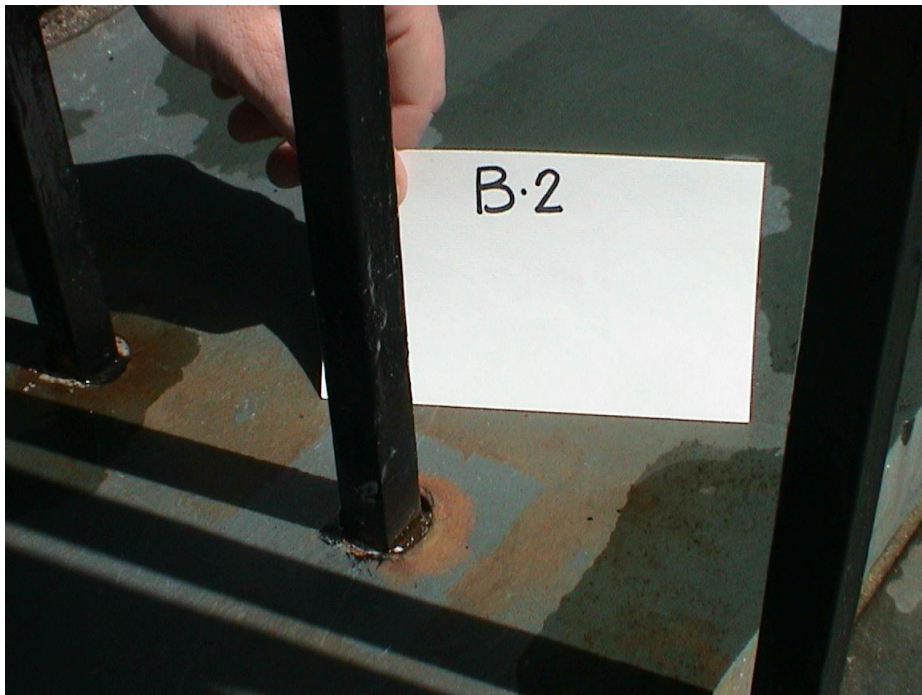
Figure 28. The orthophosphoric acid and talc poultice removed some of the rust stains on test area B-2.

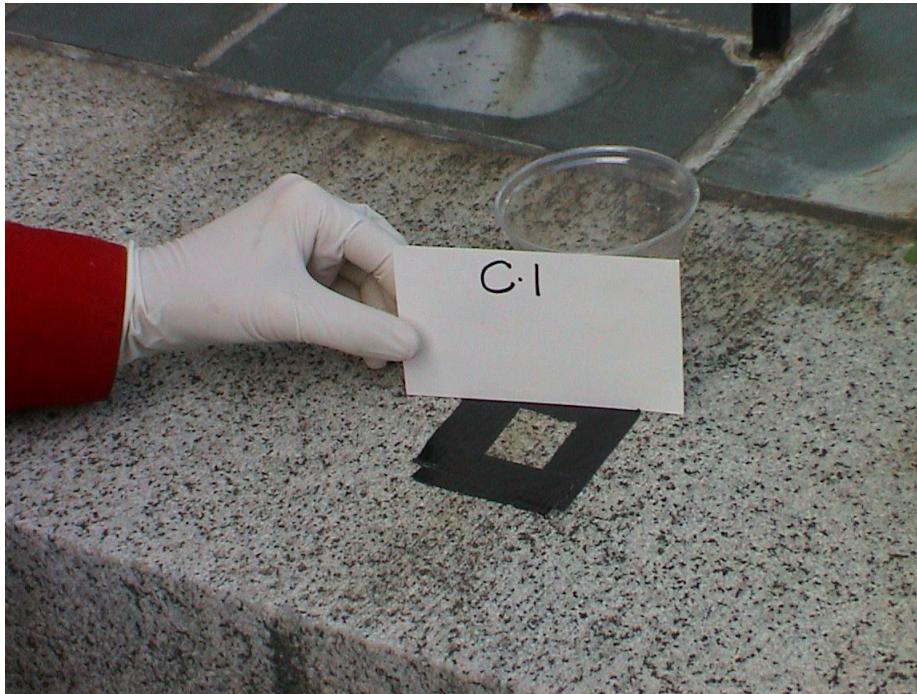
Figure 29. Tape is placed on a granite surface create a new test area labeled C-1.

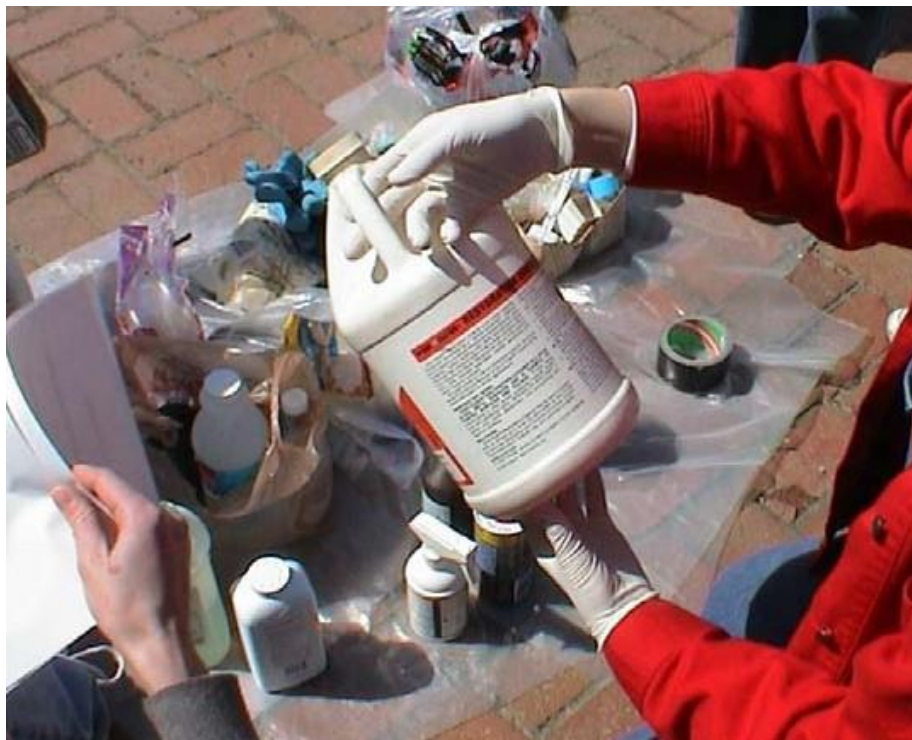
Figure 30. A solution of hydrofluoric acid and water is prepared for test area C-1.

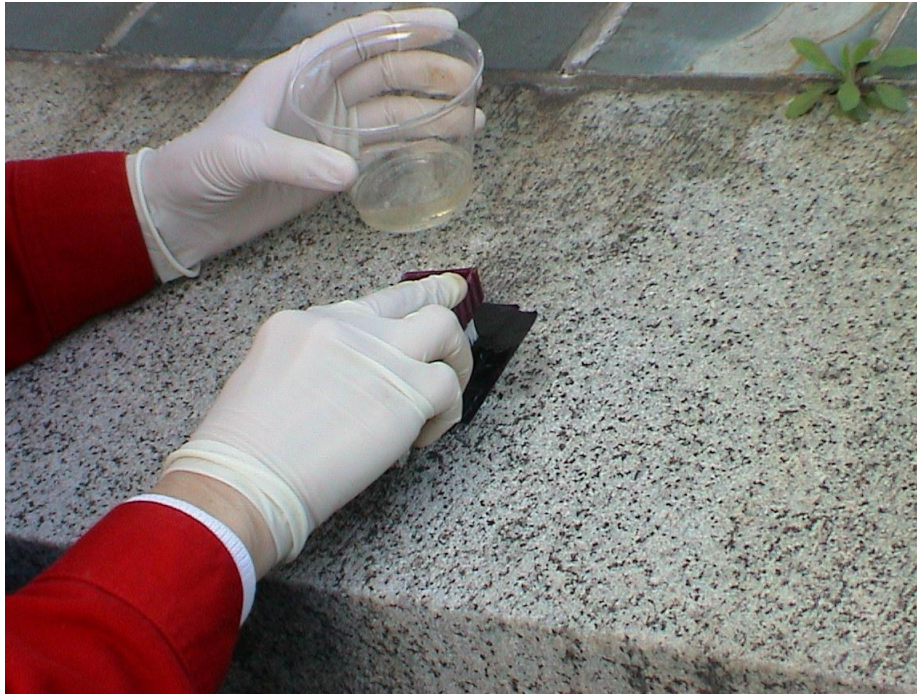
Figure 31. The hydrofluoric acid and water solution is brushed into the surface of test area C-1.

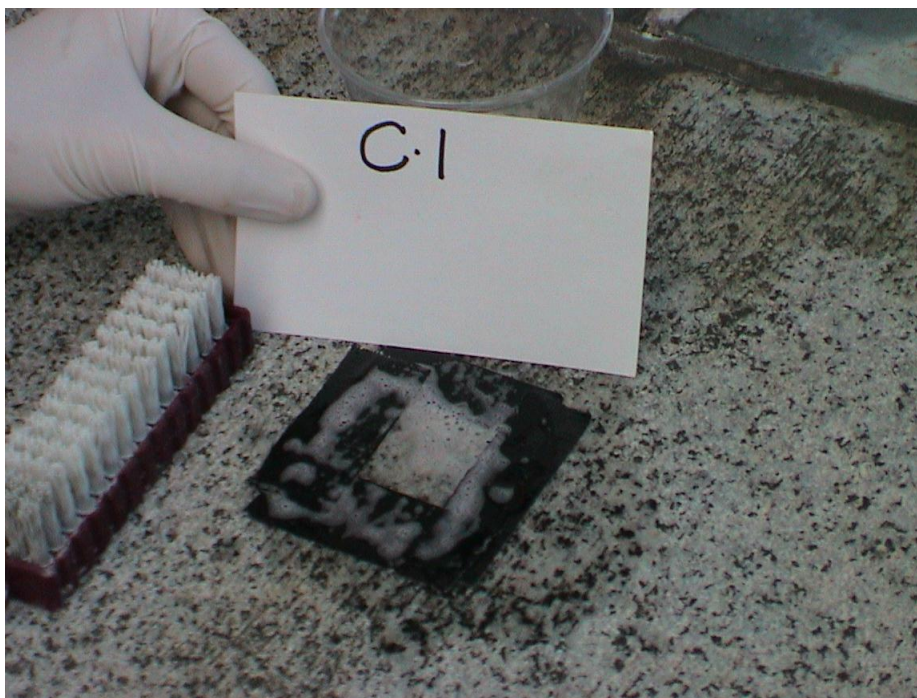
Figure 32. After applying the hydrofluoric acid and water solution, it is given time to clean the surface of the granite.

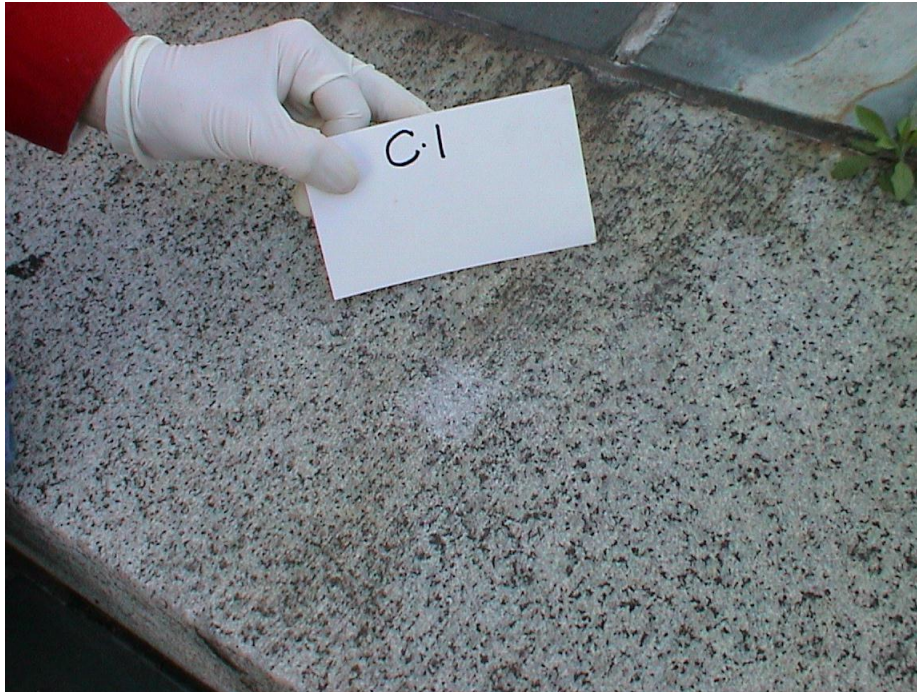
Figure 33. This photograph shows test area C-1 after the hydrofluoric acid and water solution was rinsed away, and the surface left to dry.

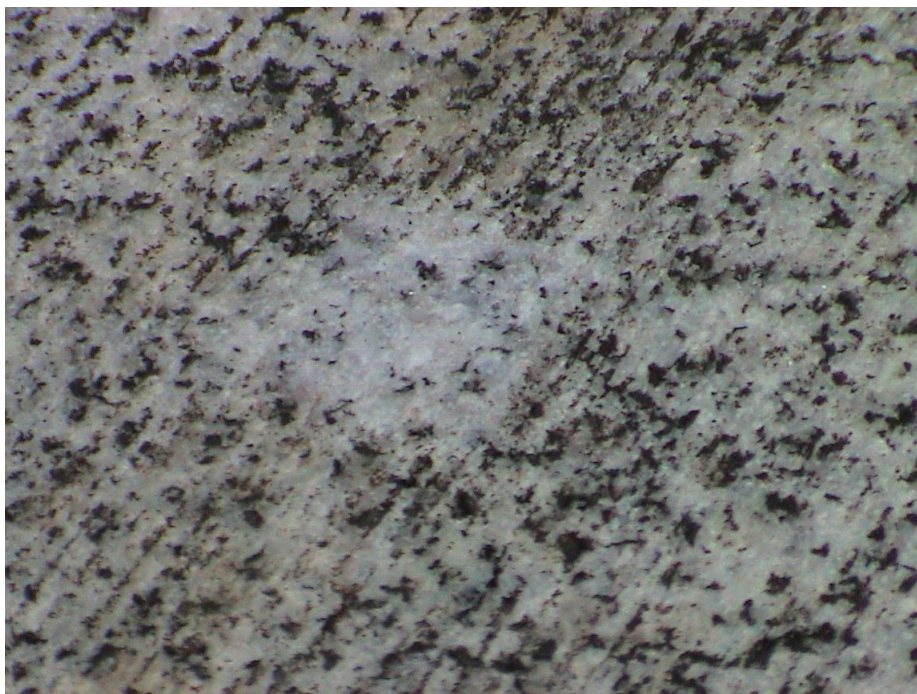
Figure 34. This is a close-up of test area C-1 after cleaning.

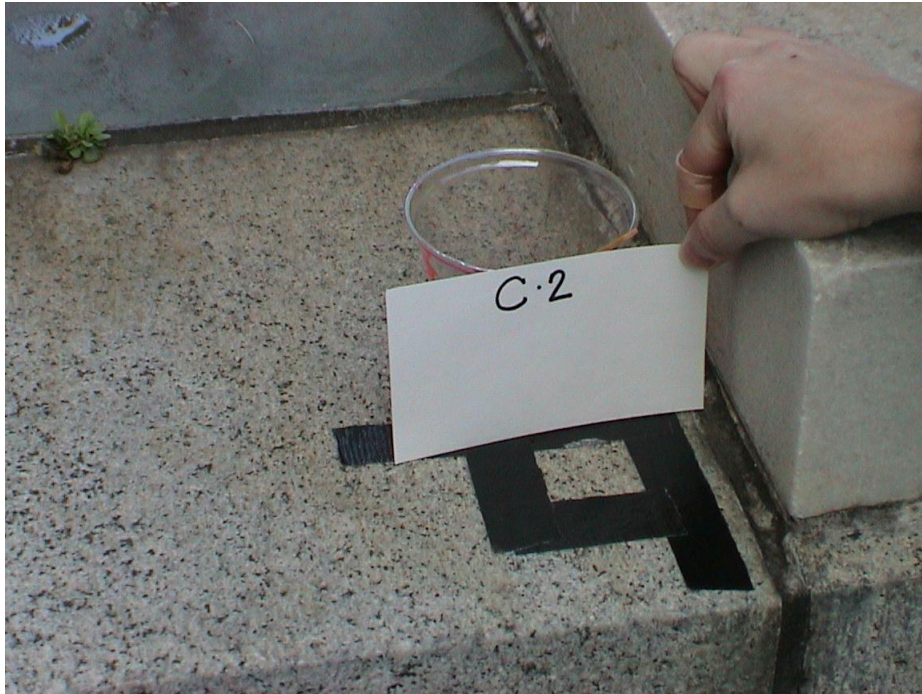
Figure 35. Tape is placed on a granite surface. The new test area labeled C-2.

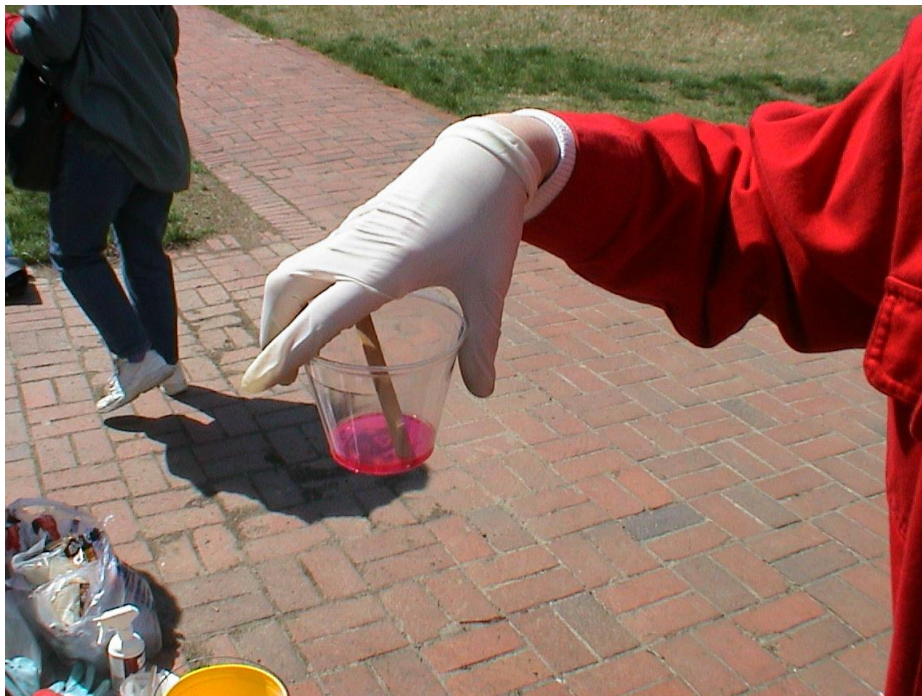
Figure 36. An orthophosphoric acid poultice is prepared for the test.

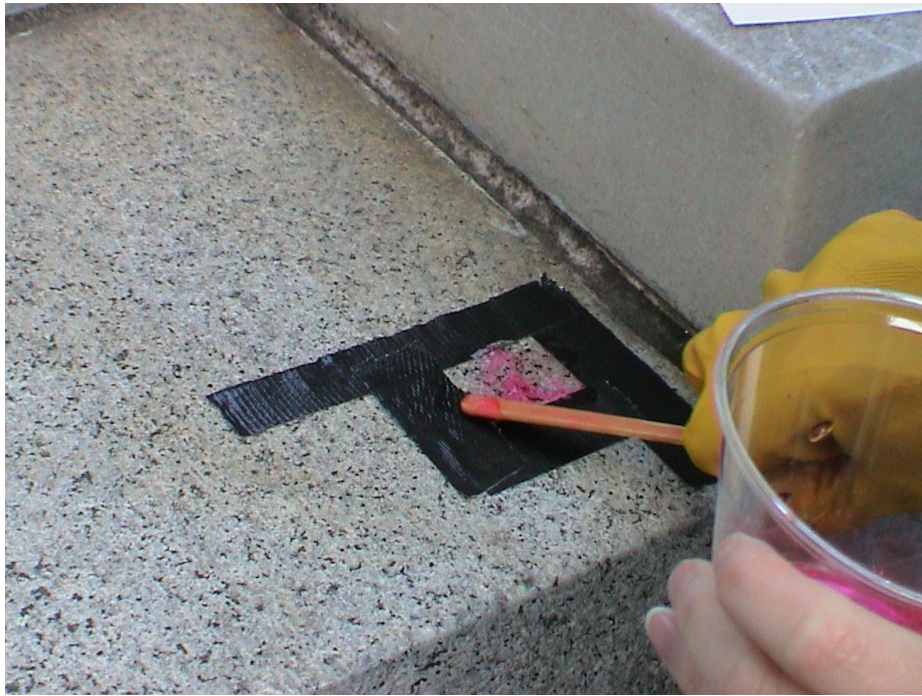
Figure 37. The orthophosphoric acid poultice is applied to test area C-2 with a wooden applicator.
